Docket No. 217 – Development and Management Plan Inspection

Northeast Utilities Service Company Certificate of Environmental Compatibility and Public Need for the construction of a 345-kV electric transmission line and reconstruction of an existing 115-kV electric transmission line between Connecticut Light and Power Company's Plumtree Substation in Bethel, through the towns of Redding, Weston, and Wilton, and to the Norwalk Substation in Norwalk, Connecticut.

Date: October 13, 2006

Location: 345kV Underground Route

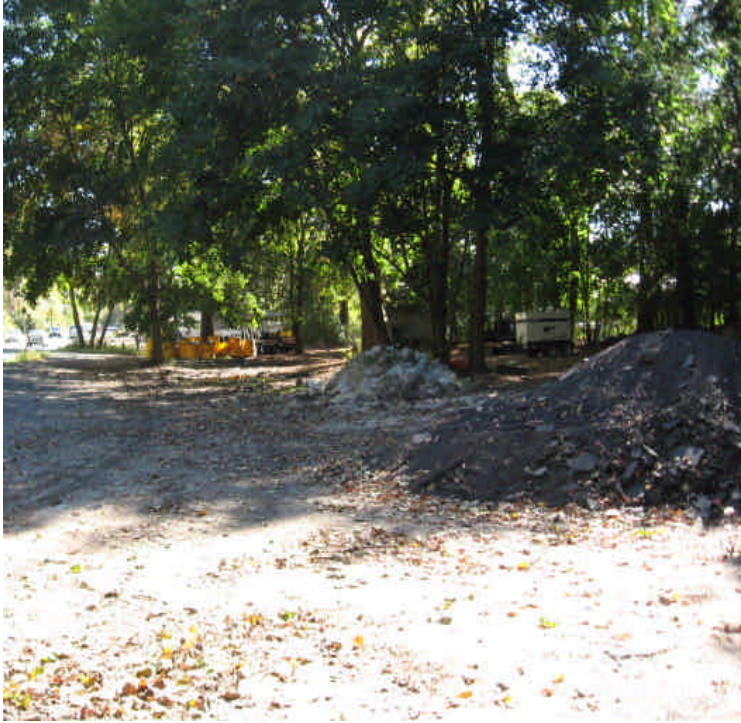
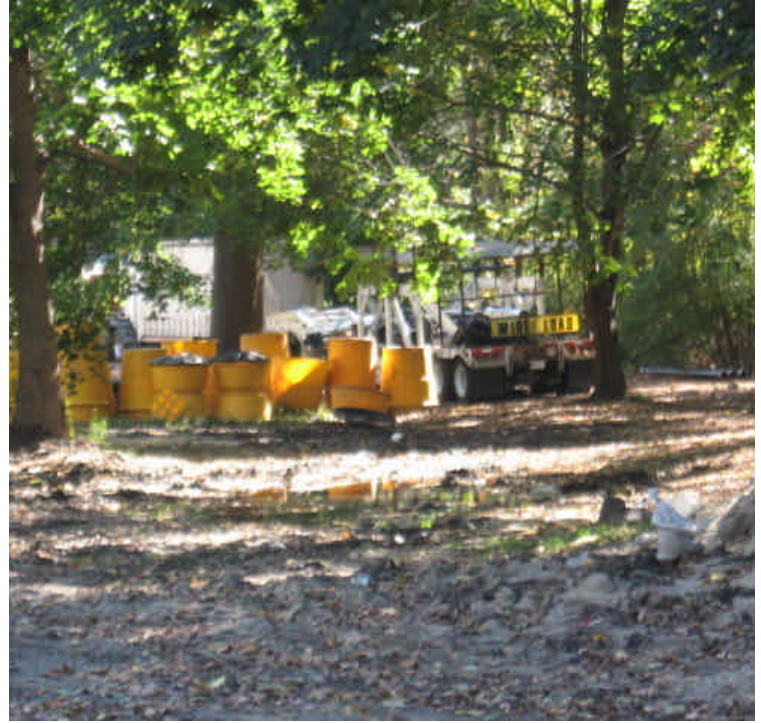
Both photos show the Four Seasons racquet club where equipment from the project is stored. When access is complete and the area is demobilized, it will have to be restored to original conditions. 10/13/06

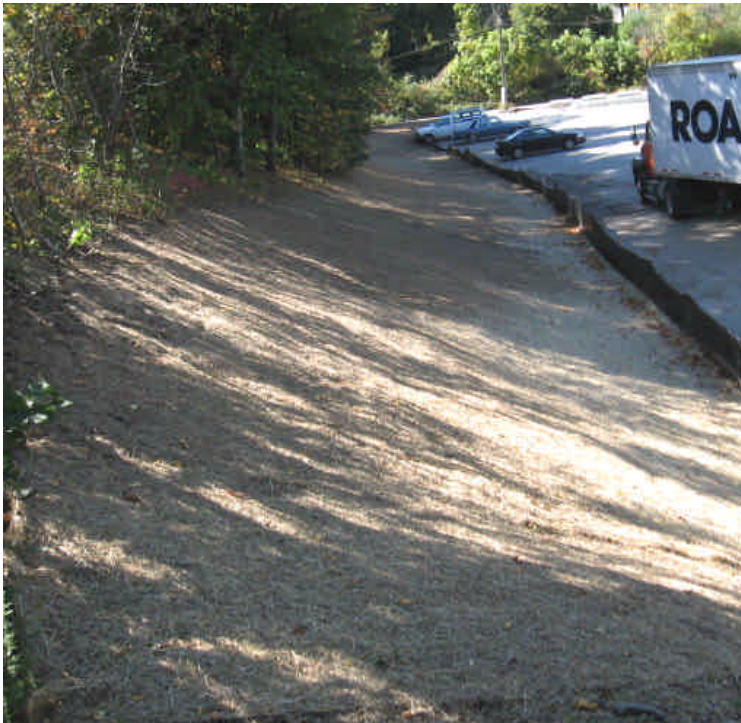
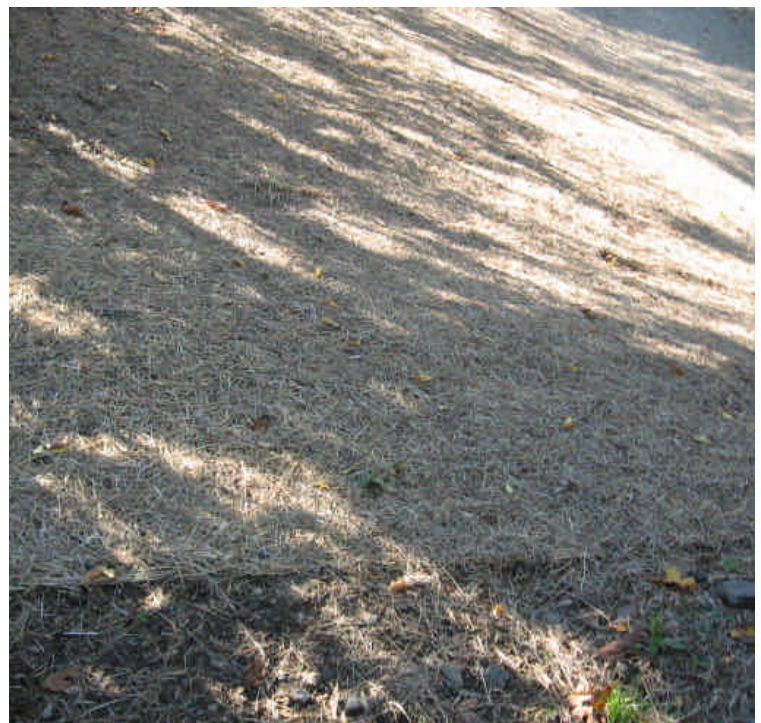
Photo on the left shows a view of the erosion control mats recently installed along the slope at the Gilbert & Bennett lot. Photo on the left is a close up of the mat. The area is in good shape. 10/13/06

Areas of Inspection	Observation	Recommended Action	Corrective Action
Rt. 107 Erosion and Sediment (E&S) Controls continued	<ul style="list-style-type: none"> - Catch basins near the Rt. 107 & 7 intersection do not have filters/ controls in place. Some disturbed soil/ stockpiles are present although portions have been restored. 7/12-10/13/06 - Sedimentation was noted to the roadway here. 10/4-10/13/06 - At the Georgetown HDD site (Gilbert & Bennett lot), the slope has been seeded and an erosion control mat was installed. Good controls remain in place. 10/13/06 	<ul style="list-style-type: none"> - Finalize restoration of the island when access is complete. 4/6-10/13/06 - Erosion control mats were installed along the slope and the area is in good shape. 10/13/06 	<ul style="list-style-type: none"> - Needs attention when feasible unless the Rt 7 project will affect this location soon. - Erosion control mats were installed.

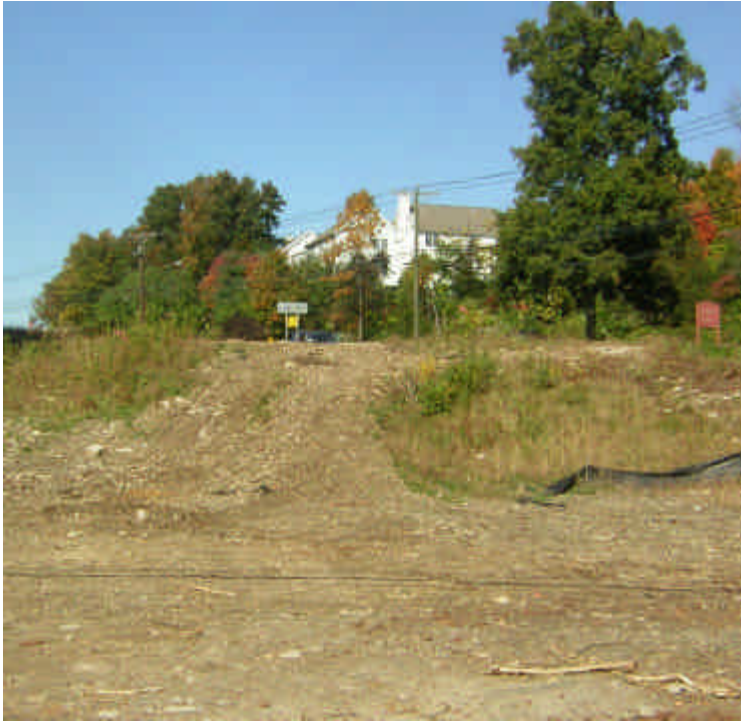
Photo on the left shows a view of the demobilized storage area across from Old Highway Rd. This area should be seeded and mulched if it will not be affected in the near future by the Rt 7 project.

Adjacent Wetlands and Waterways	<ul style="list-style-type: none"> - All resource areas were restored following the 345kV project work. 10/13/06 	-None 10/13/06	- N/A
Staging, Storage, and Parking Areas	<ul style="list-style-type: none"> - The storage area along Rt 7 across from Old Highway Rd was graded and demobilized but the soil surface is still exposed. 8/30-10/13/06 - The racquet club storage yard has a pile of sandbags and other equipment stored here. This area is still highly utilized with ruts in the soil surface and an unprotected swale. 9/13-10/13/06 -The contractor trailer yard was also being demobilized and restored to original conditions. 10/13/06 	<ul style="list-style-type: none"> -Restore, seed and mulch when feasible. 8/30-10/13/06 Generally, guidelines state that fall seeding should be completed by Oct 15th. - Install haybales at the culvert within the swale in an attempt to filter run-off. 2/2-10/13/06 -Restore/ stabilize area when feasible. 9/13-10/13/06 -None. 10/13/06 	<ul style="list-style-type: none"> - Needs attention when feasible unless it will be affected by Rt 7 project work. - Needs attention -N/A

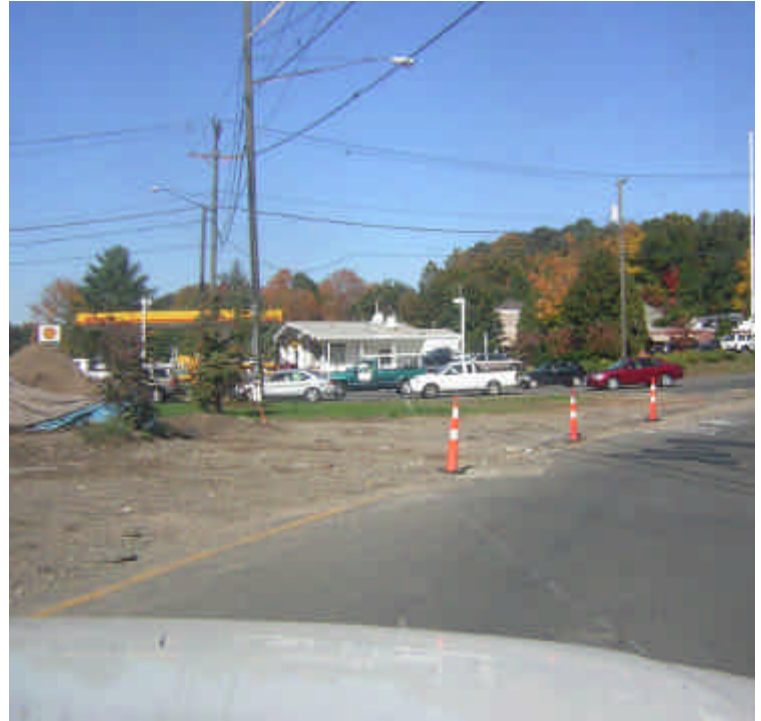
Photo on the right shows the Rt 7/107 intersection where a few stockpiles remain and some restoration is still needed. 10/13/06

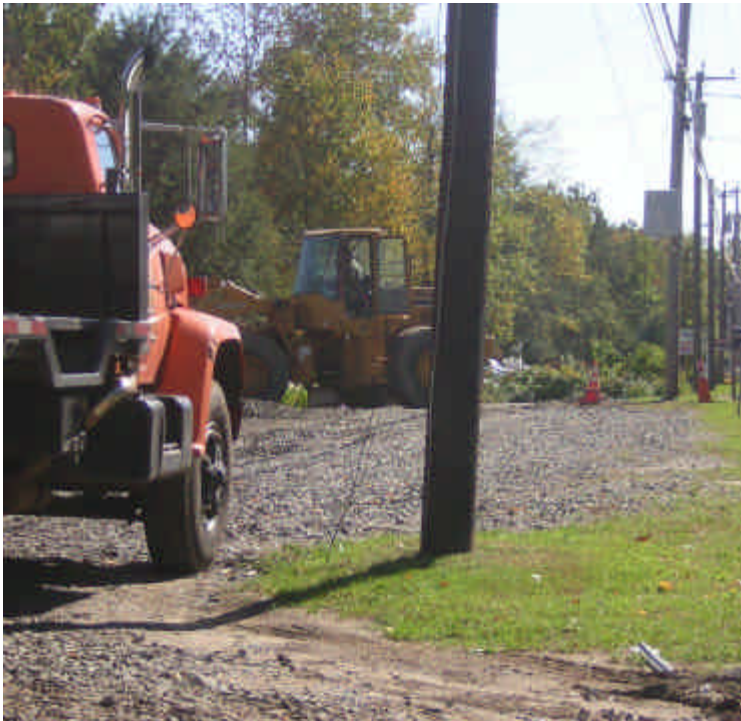
Photo on the left shows demobilization of the contractor trailer yard along Rt 7. Photo on the right shows works along Rt 107 to bring the road to grade. 10/13/06

Soils	<ul style="list-style-type: none"> - Topsoil is stockpiled and stabilized with vegetation at the contractor trailer yard off Rt 7 but it will likely be returned/graded in the yard soon as the area is being restored. 10/13/06. 	<ul style="list-style-type: none"> - Soils appear to be handled appropriately. Seed as soon as practical once it is placed back in the yard 10/13/06 	-N/A
